Report No. CG-D-13-15

Evaluation of Rutter Sigma S6 Ice Navigation Radar on USCGC Healy during Arctic Shield 20

March 2015

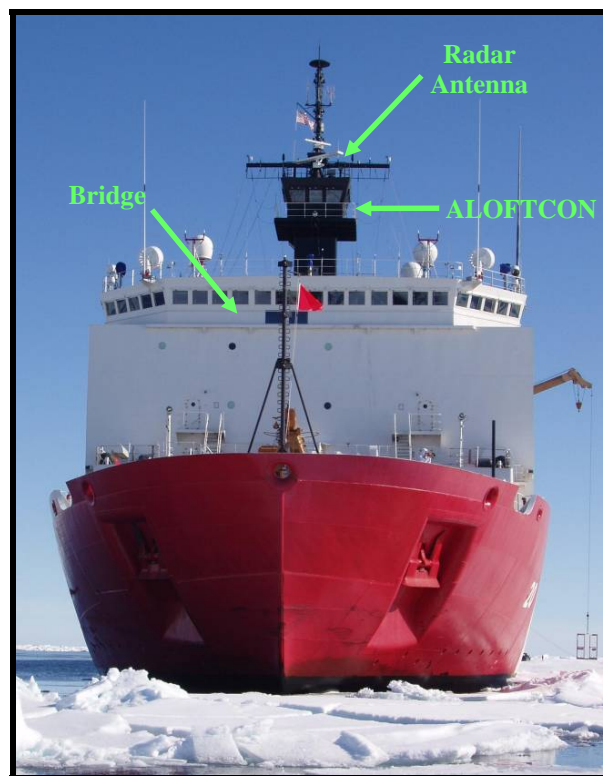
Figure 1. External view of USCGC Healy from the front.

The Ice Navigation radar display could be stationed in two possible locations: the Chart Planning Station on the bridge or the ALOFTCON. Figure 1 shows locations of the radar antenna, ALOFTCON and the ship's bridge.

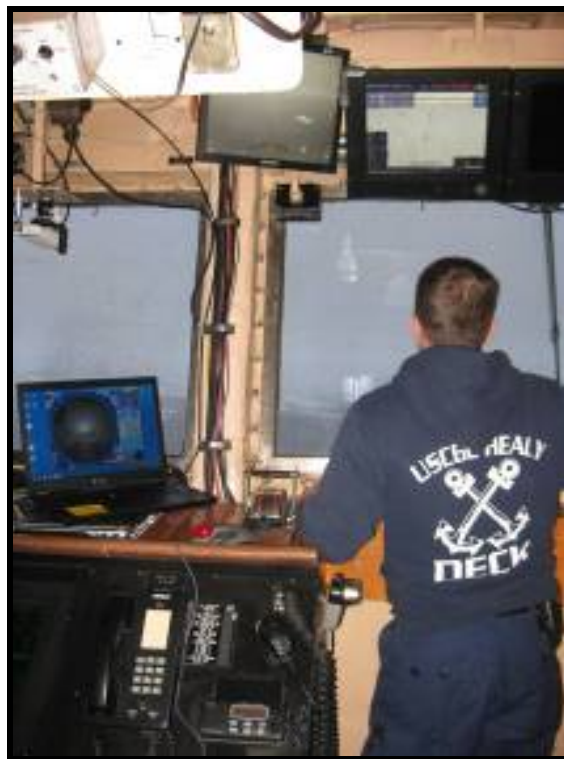
Figure 3. Setup of Rutter-configured laptop in the ALOFTCON with OOD navigating.

If the weather deteriorated or thick fog appeared while navigating, the OOD transferred ship controls to the ALOFTCON to gain better visibility of the surrounding environment. When this occurred, a laptop configured with Rutter software was used to show the Ice Navigation radar display. This was made possible with an Ethernet cable that ran from the Chart Planning Station, where it was plugged into the Rutter computer, to the ALOFTCON where the other end was plugged into the laptop. This made for a very comfortable setup for the OOD as the Ice Navigation radar display was situated directly next to him/her while navigating (See Figure 3).

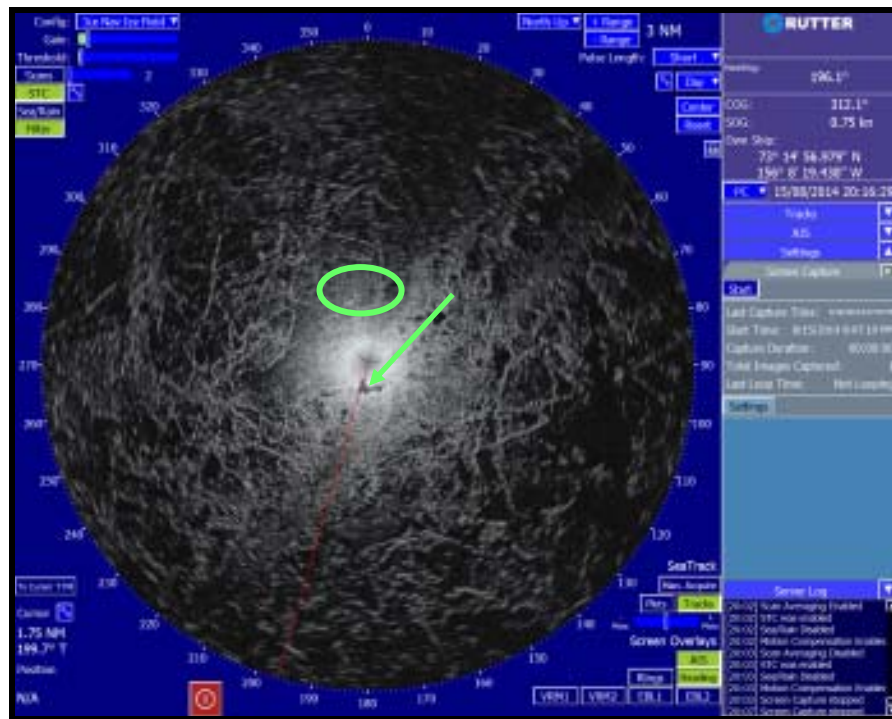
Figure 4. Ice Navigation radar screen capture during Stationary Procedure (3 nm range scale; arrow indicates the clearly defined patch of open water in front of ship; circle indicates ice field).

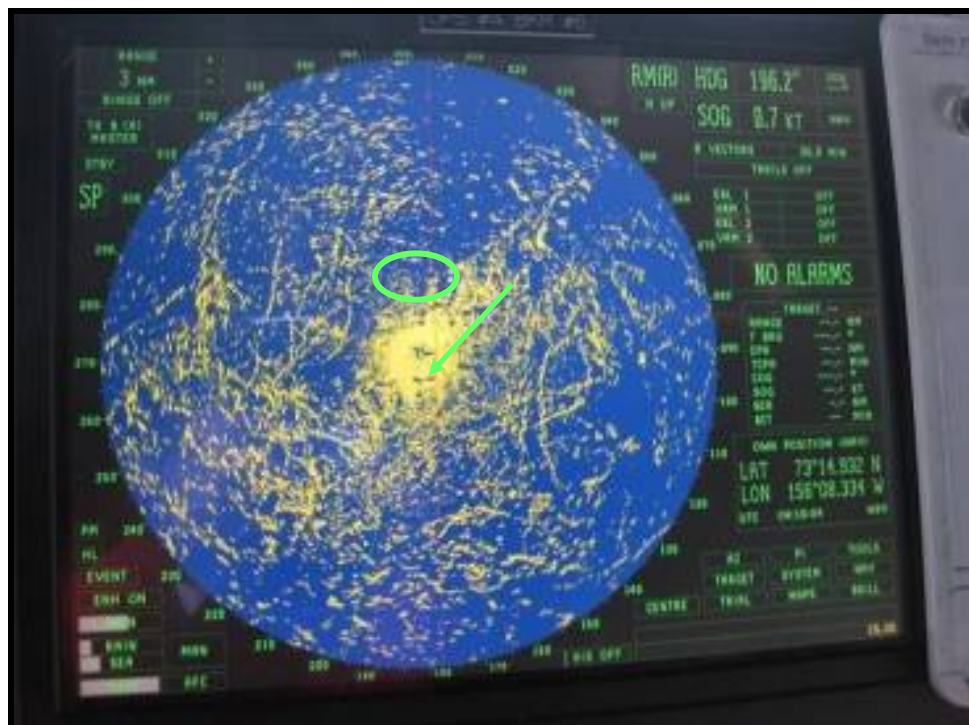
Figure 5. Photograph of Coast Guard radar display during Stationary Procedure (3 nm range scale; arrow indicates the patch of open water, which is difficult to discern on this display; circle suggests open water).

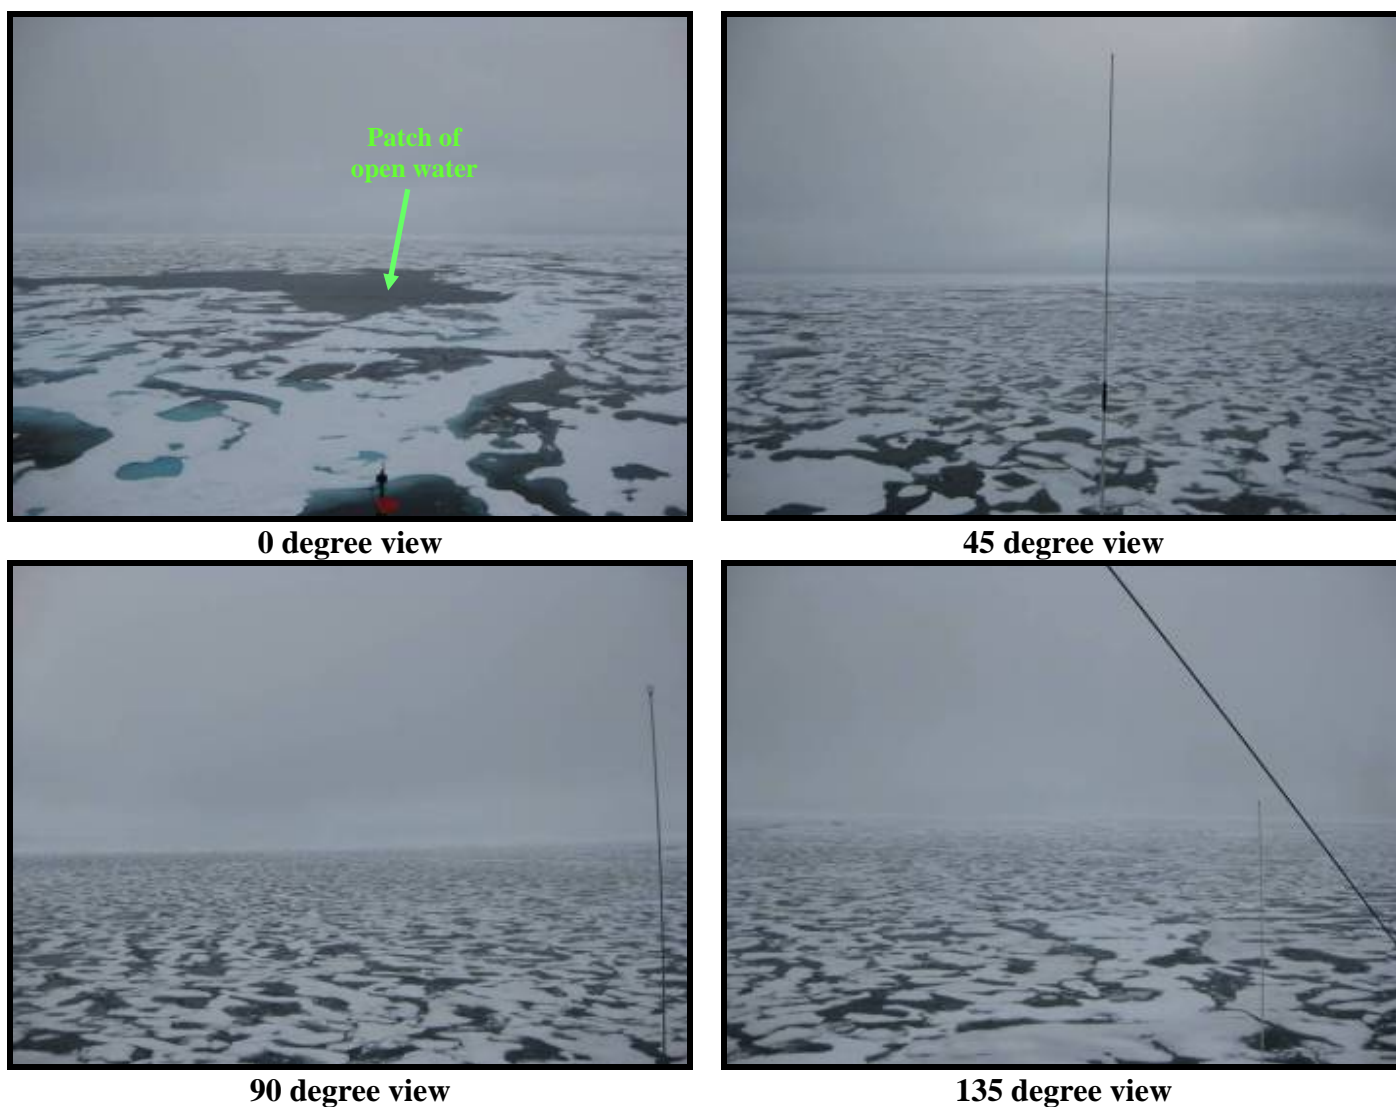
Figure 6. 0 - 135 degree relative bearing views of ice infested field.

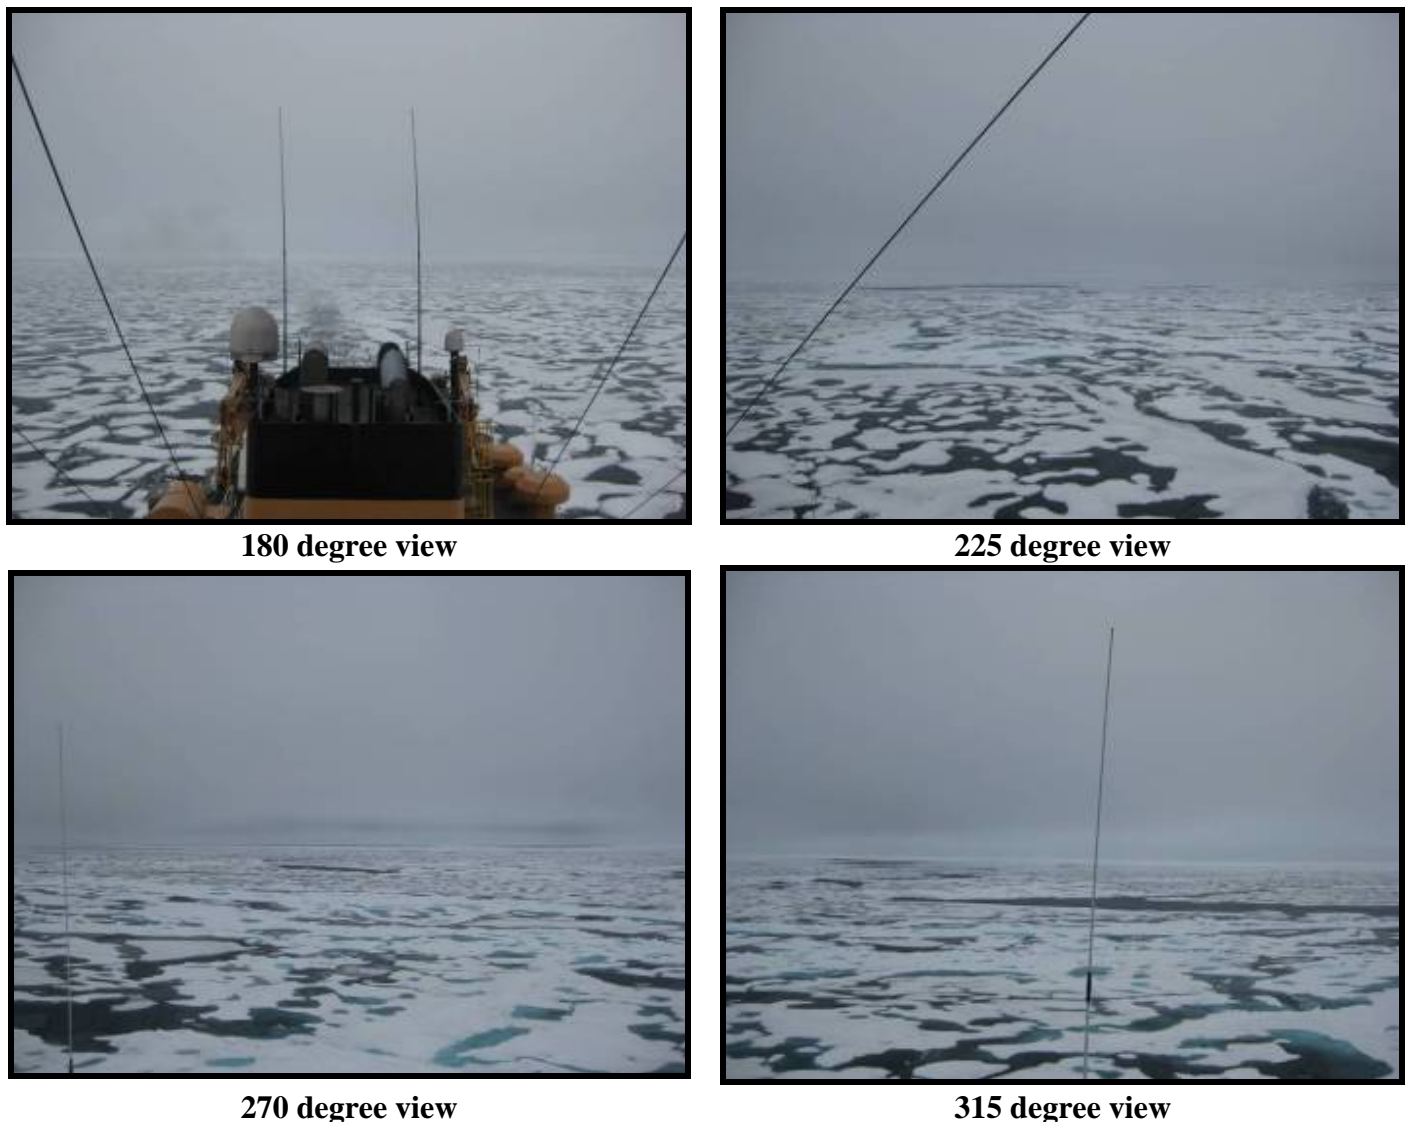
Figure 7. 180 – 315 degree relative bearing views of ice infested field.

The ice and sea surface features were more clearly identifiable on the Rutter radar display out to a range of approximately 3 nm. At this same range, the CG radar system becomes unreliable as the ice conditions are not clearly visible. On the Ice Navigation radar, when the range increases, the resolution decreases slightly but it still provides more details when compared with the CG radar at the same range. The differences between the two are shown more clearly in Figures 8 and 9. This side-by-side comparison is one of the many examples that prove that the Rutter radar display provided significantly superior surface texture information, both in near and far range. In Figure 8 and the subsequent 360-degree view photographs in Figures 10 and 11, it is evident that the ship is facing a body of open water. However, the CG radar display (Figure 9) does not show the full extent of the open water directly in front of the ship. Additionally, there is very little information about the ice field after approximately 1.5 nm in the CG radar display.

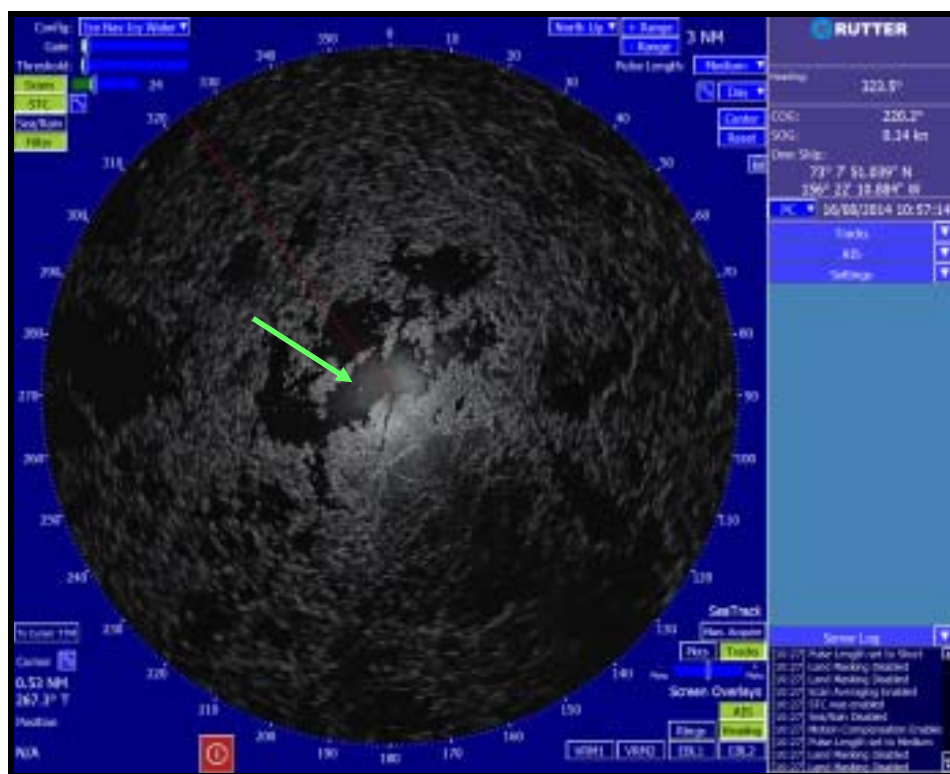
Figure 8. Ice Navigation radar screen capture during Stationary Procedure (3 nm range scale; arrow indicates location of a small ice chunk in an area of open water).

From the data collection, it is again evident that the Ice Navigation radar shows a clearer picture of the surrounding environment. It is even able to show clearly the path of broken ice behind the ship whereas the CG radar system vaguely shows this path in the ice. The small piece of ice circled in Figure 11 shows up on the Ice Navigation radar display (Figure 8) but is not clearly depicted on the CG radar display (Figure 9). These examples further illustrate that the Ice Navigation radar system provided useful, high resolution images of the surrounding icy environment.

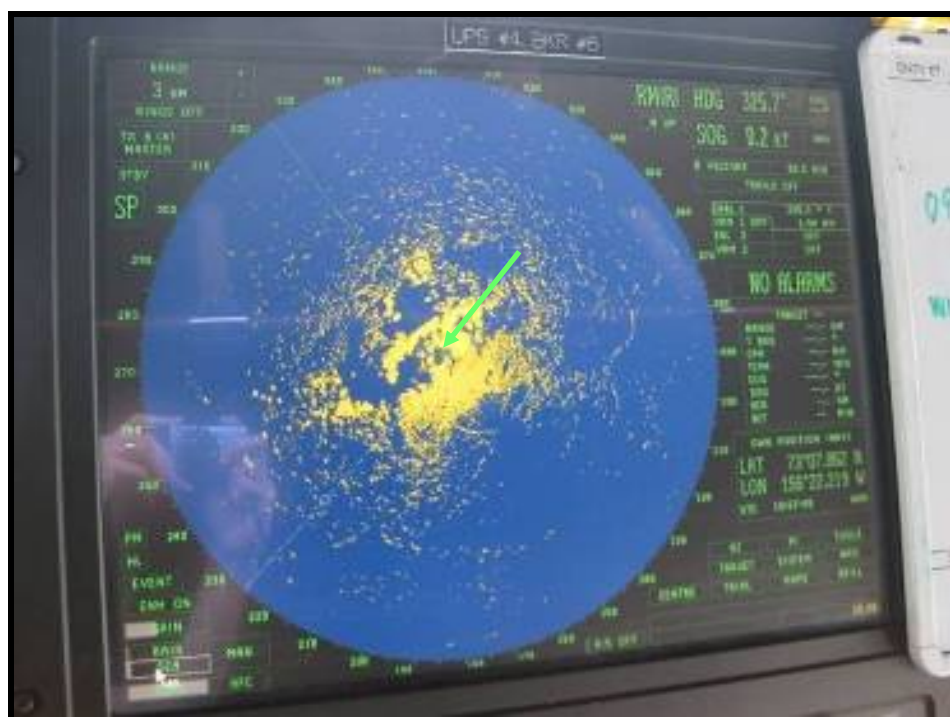
Figure 9. Photograph of Coast Guard radar display during Stationary Procedure (3 nm range scale; arrow shows how that particular region on the radar screen shows less resolution than that of Figure 8).

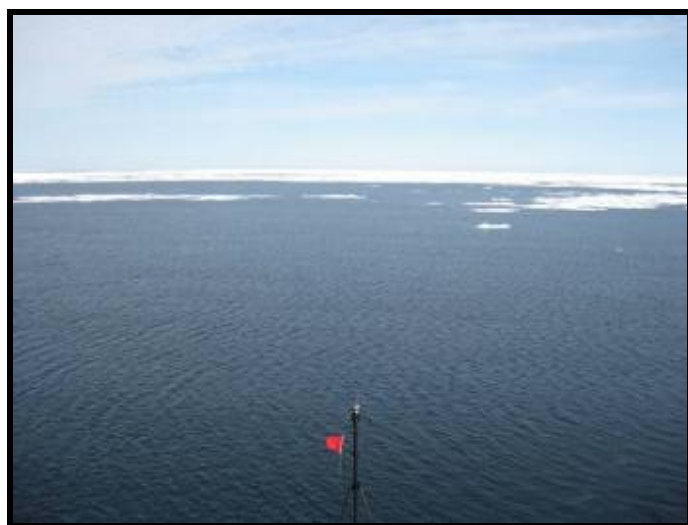
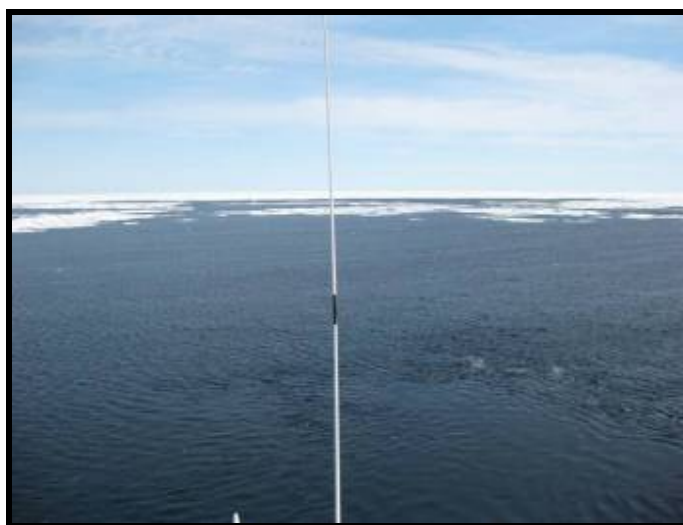
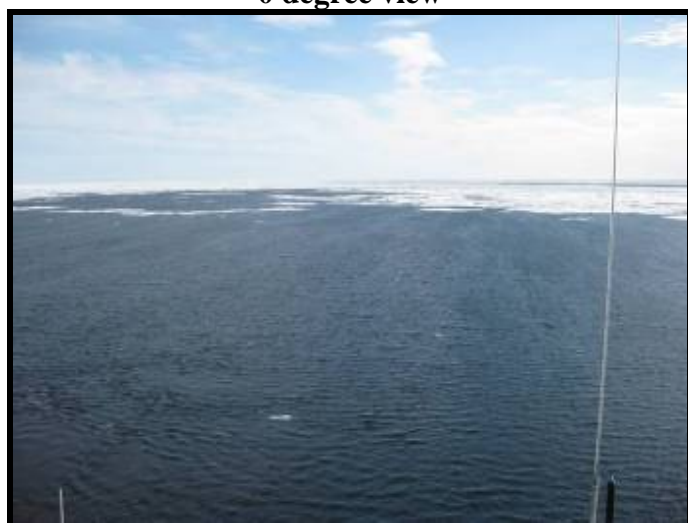
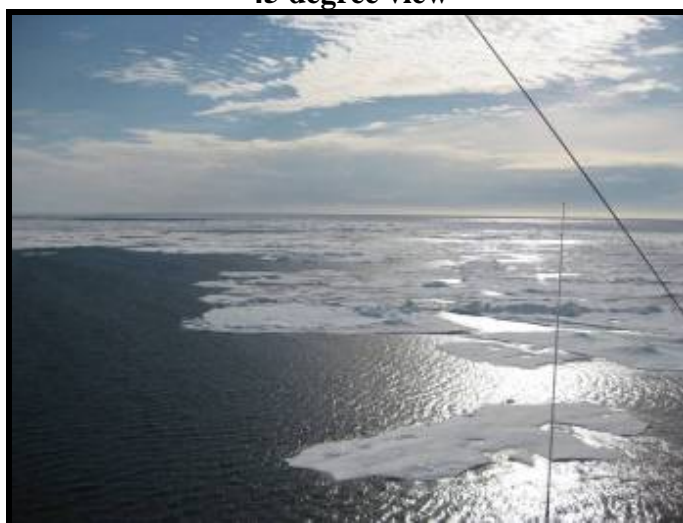
Figure 10. 0 - 135 degree relative bearing views of test area with open water.

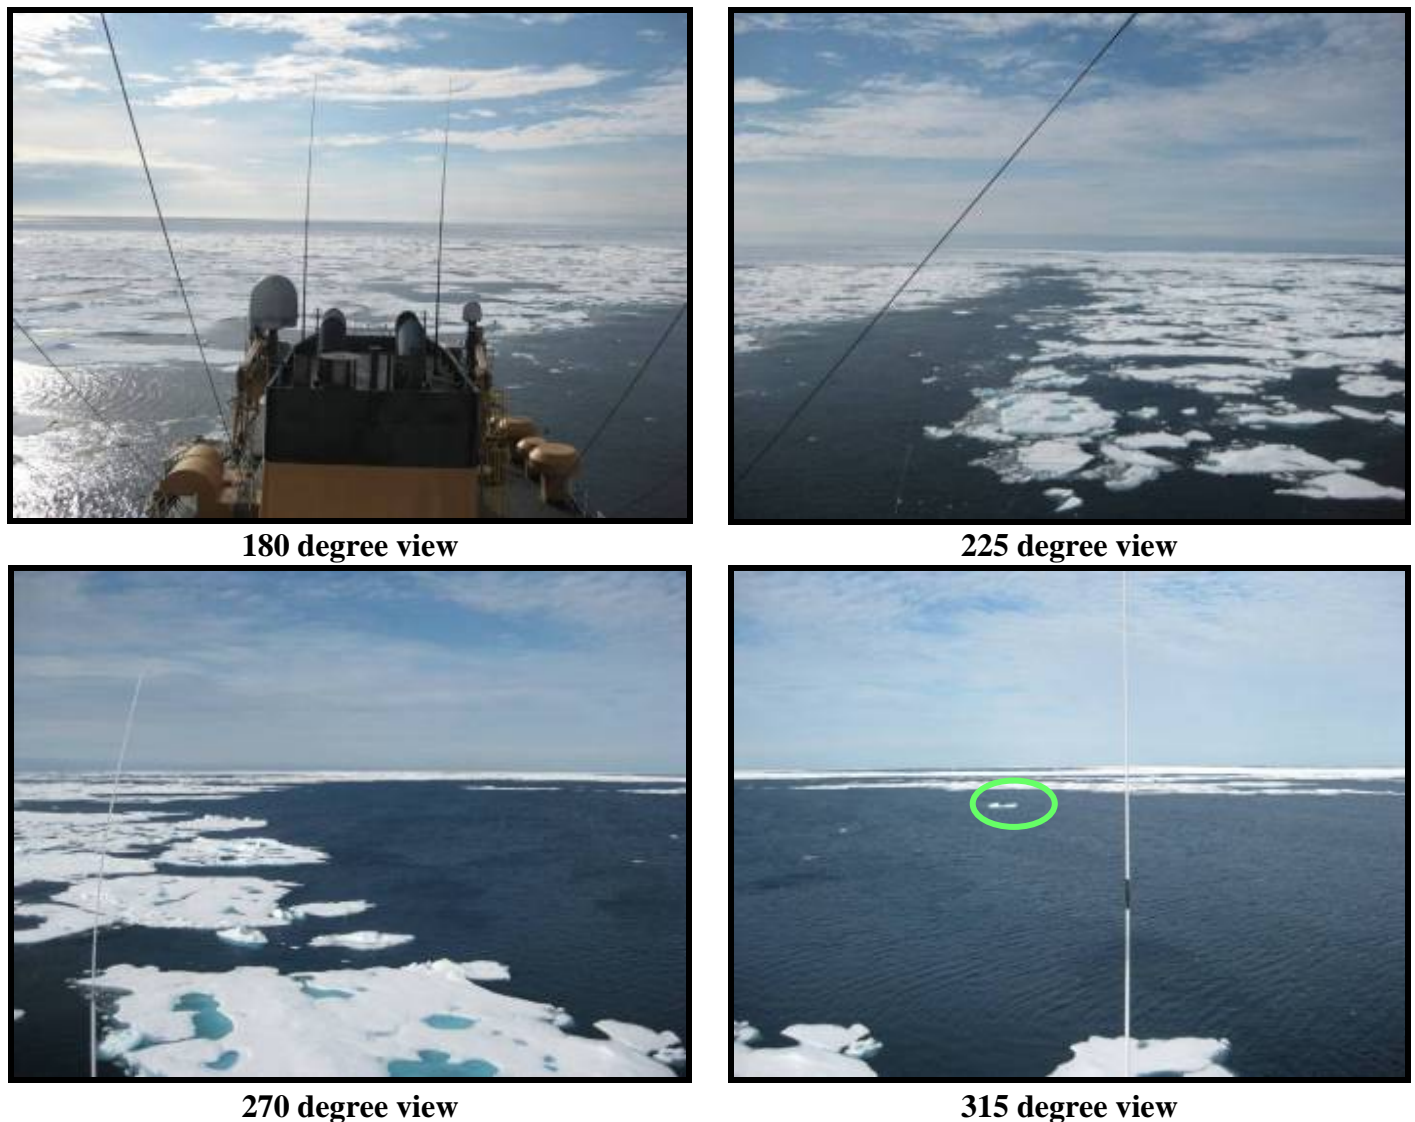
Figure 11. 180 – 315 degree relative bearing views of test area with open water (Circle indicates a small ice chunk visible in the Figure 8 radar image).

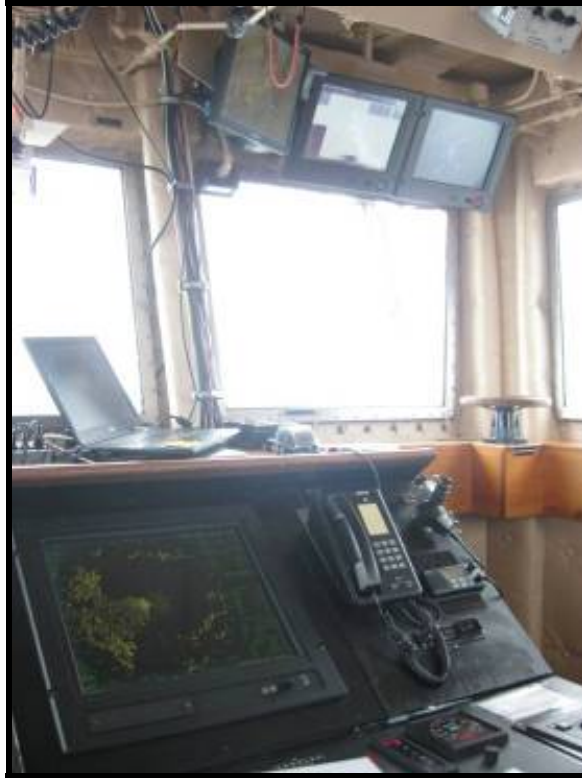
Figure 12. Rutter-configured laptop setup in the ALOFTCON.

The ALOFTCON with a Rutter-configured laptop was found to be the more ideal location for the Ice Navigation radar display as compared to the Chart Planning Station on the bridge. The laptop display could be set directly to the left where the OOD stands and in front of the window (See Figure 12). This vantage from the ALOFTCON

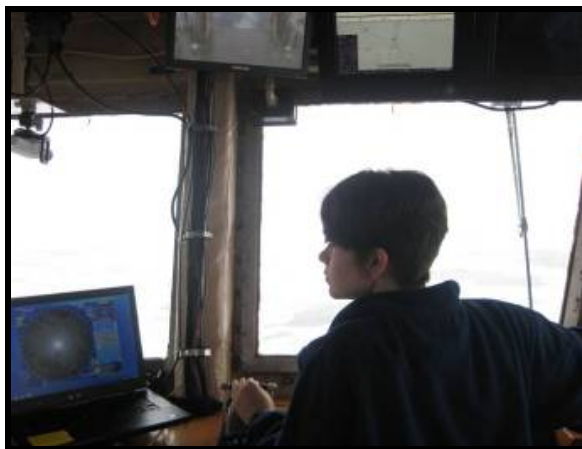
Figure 13. OOD utilizing the Rutter-configured laptop during navigation during poor weather in the ALOFTCON.

allowed the OOD to see out the window and simultaneously observe the Ice Navigation radar display with ease (See Figure 13). When this setup was engaged, the current CG radar display in the ALOFTCON was not used since the laptop radar display provided a superior picture in a better location.

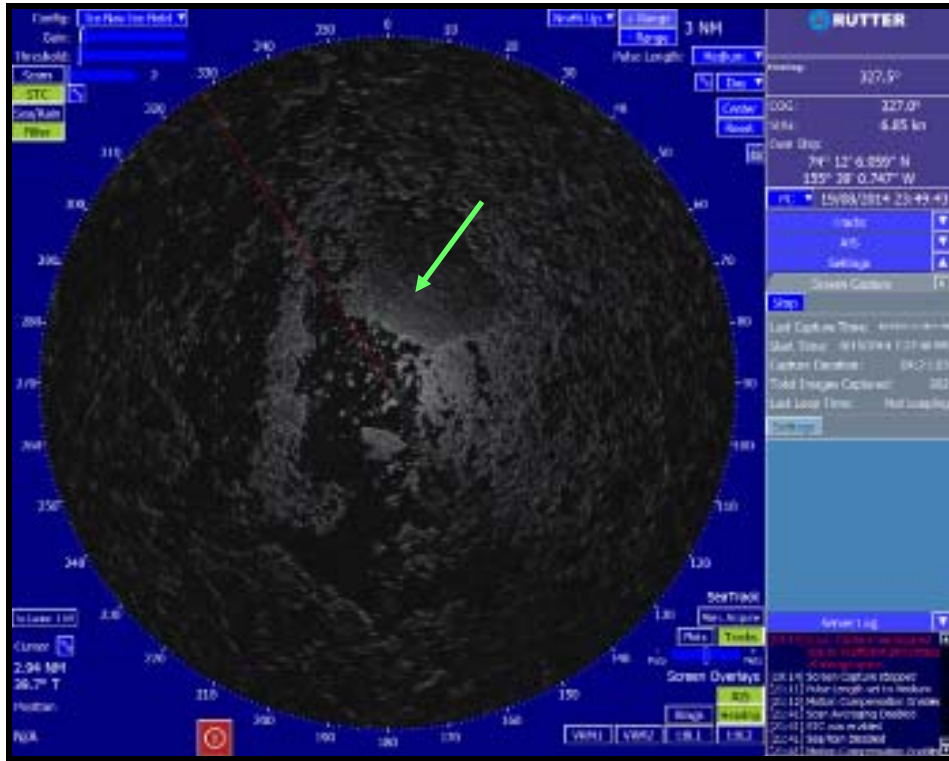
Figure 14. Arrow indicates thin ice field shown on Ice Navigation radar 30 degrees east of the ship's heading and 0.5 nm away (3 nm range scale).

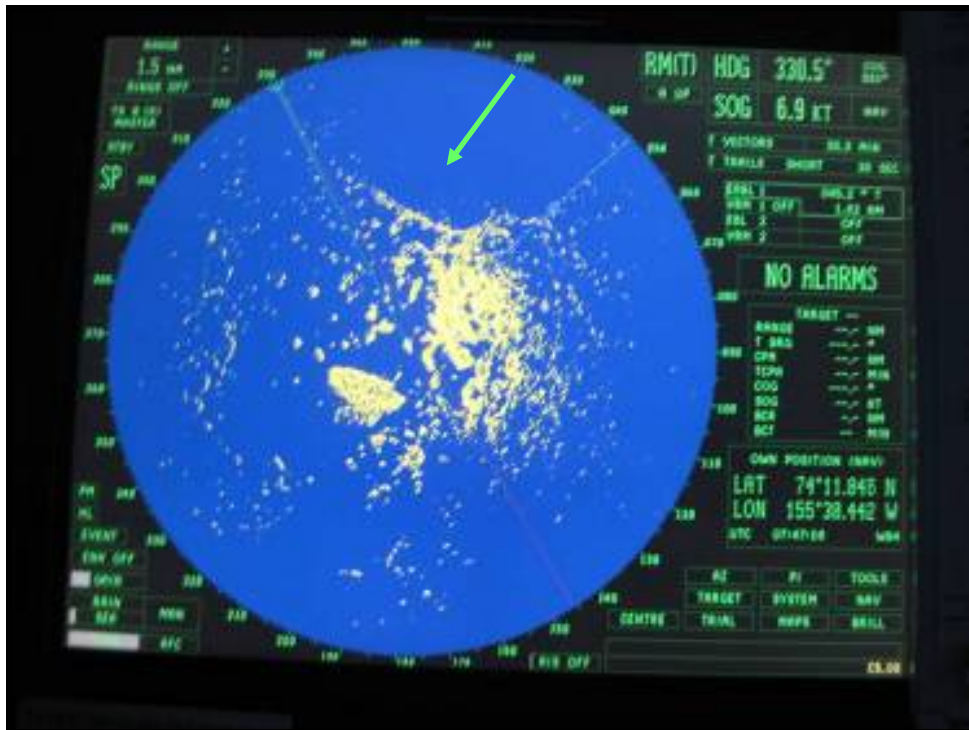
Figure 15. Arrow indicates lack of distinguishable ice field shown on CG radar 30 degrees east of the ship's heading and 0.5 nm away (1.5 nm range scale).

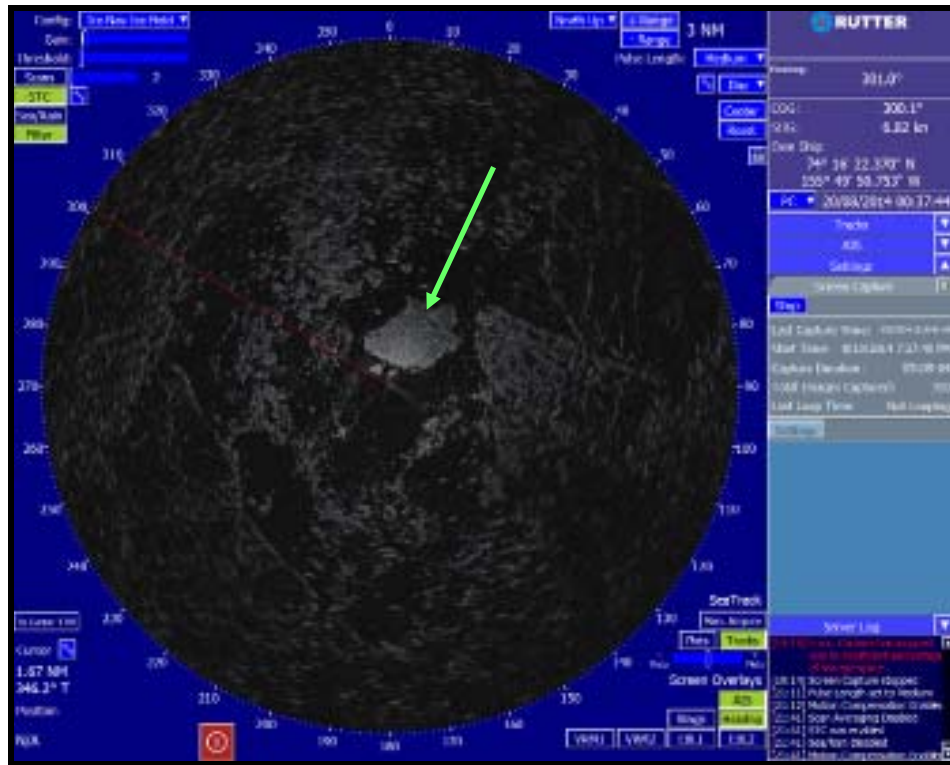
Figure 17. Heading to the left of ice floe (Red line indicates ship's heading; green arrow indicates ice floe in question; 3 nm range scale).

During one watch early in the morning on August 20, the OOD relied heavily on the Ice Navigation radar in the Chart Planning station and identified a large ice floe ahead that he took into account while navigating. Figures 17 to 20 show the path that the ship took to avoid breaking through the ice floe and maintain the ship's momentum. This particular ice floe was undetected through the window due to light fog (See Figure 21) but as the ship got closer, it became visible (See Figure 22). After the ship safely maneuvered around the ice floe, a photograph of the CG radar display (See Figure 23) was taken to compare the clarity of the ice floe in question to the Ice Navigation radar display as shown in Figure 20. The comparison between Figure 20 and Figure 23 of the ice floe south of the ship shows clearly that the extent of the ice floe is easily identified by the Ice Navigation radar but is not clearly defined by the CG radar. The ability to clearly define ice edges and identify the differences between ice and open water has large implications in choosing safer and more efficient shipping routes for the OOD.

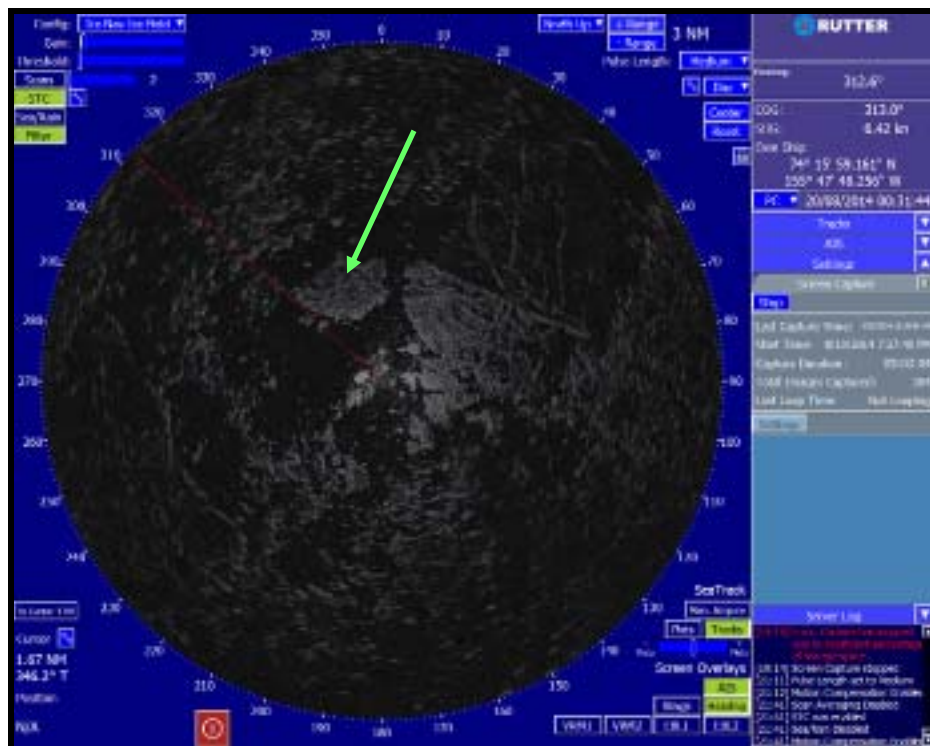
Figure 18. Avoiding the ice floe (3 nm range scale).

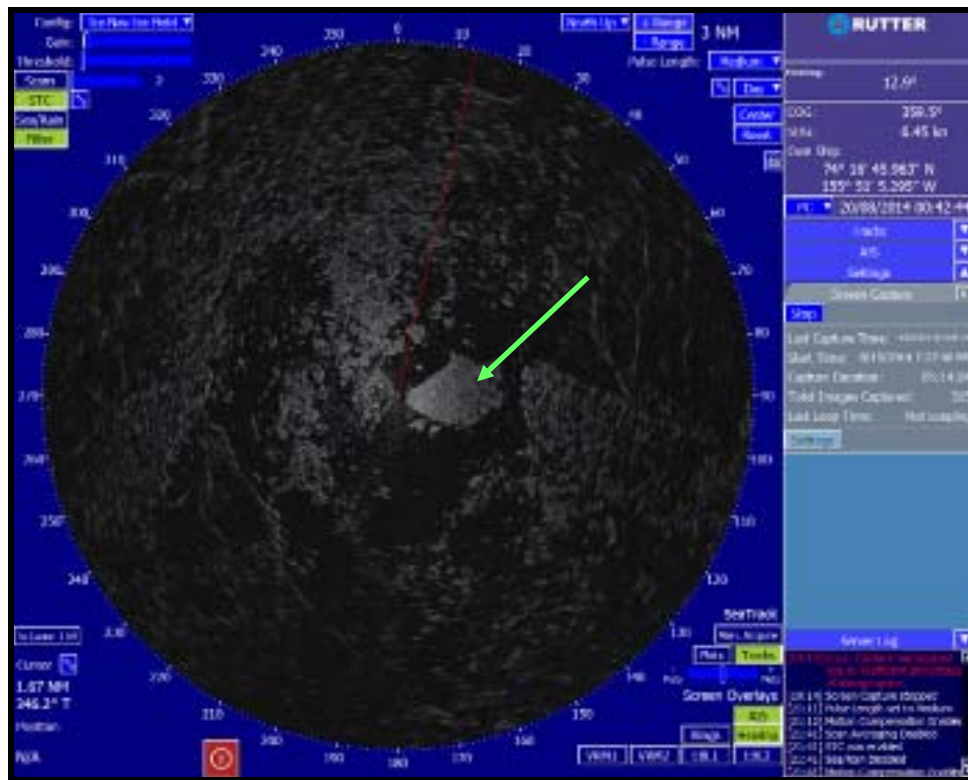
Figure 19. Rounding the ice floe (3 nm range scale).

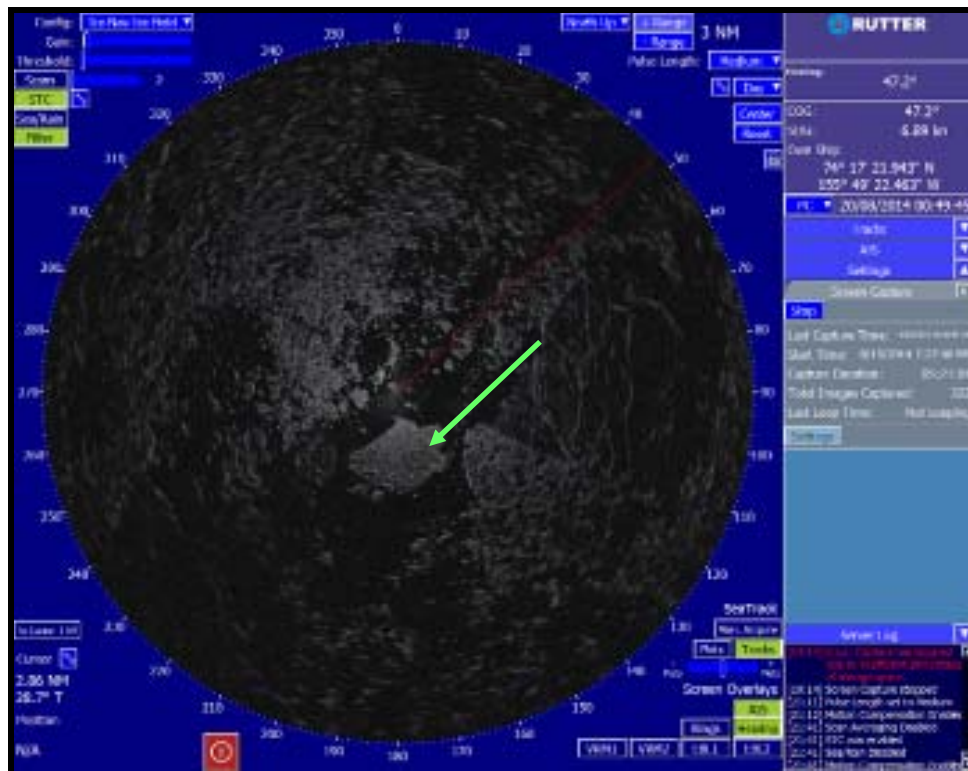
Figure 20. Cleared of ice floe and heading for patches of open water (3 nm range scale).

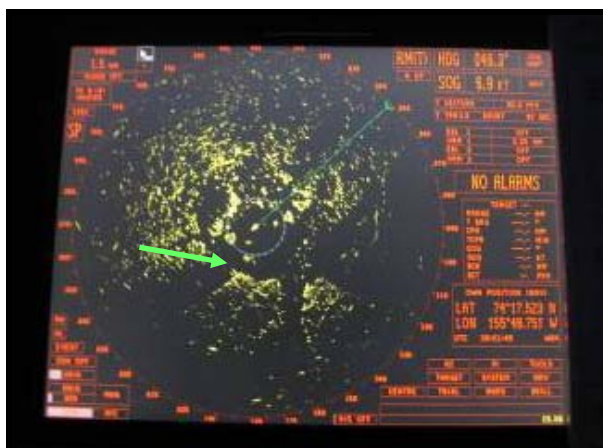
Figure 23. Extent of ice floe that was avoided (south of ship) is not clearly defined on CG radar (1.5 nm range scale).

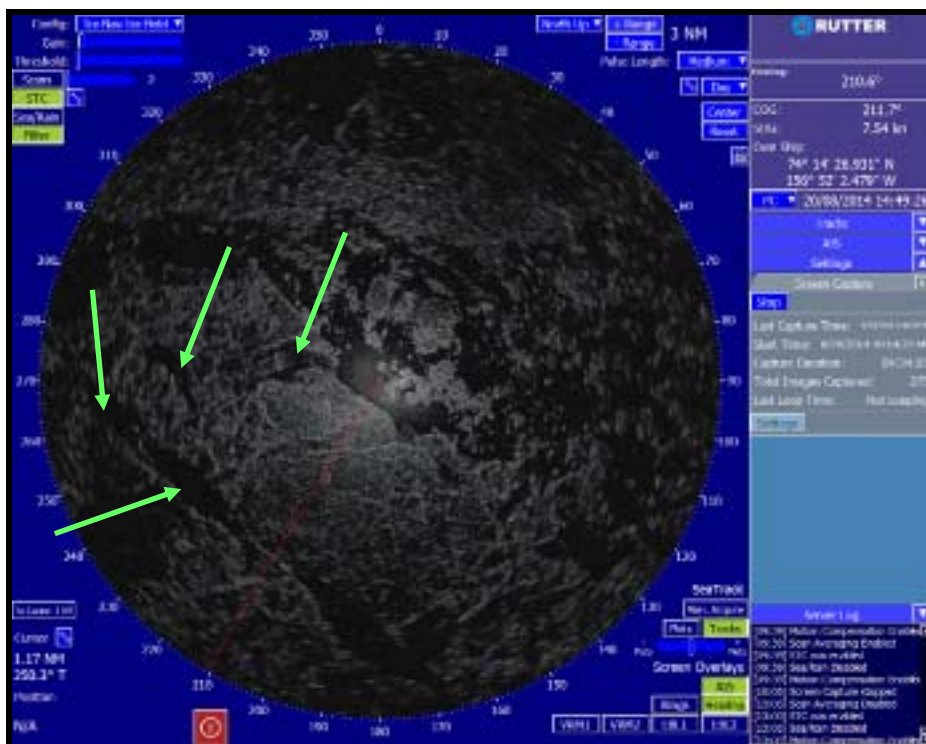
Figure 24. Upcoming ice floe that ship was stuck in; green arrows indicate the possible route ship could have taken; red line is ship's heading (3 nm range scale).

At approximately 2:55 PM on August 20, the ship found itself stuck in an ice floe. The OOD at the time was on the main bridge and chose not to use the Ice Navigation radar since it was inconveniently located in the Chart Planning Station. He relied on the CG radar and the vantage from his standing position on the bridge. Figure 24 shows what the Ice Navigation radar display captured prior to the ship becoming stuck in ice. It was clearly evident that the radar display showed a large ice floe and it was possible to avoid it by heading to the right where a channel of open water existed with loose ice ahead of it (See green arrows in Figure 24). Figure 25 shows the ship stuck in the ice floe.

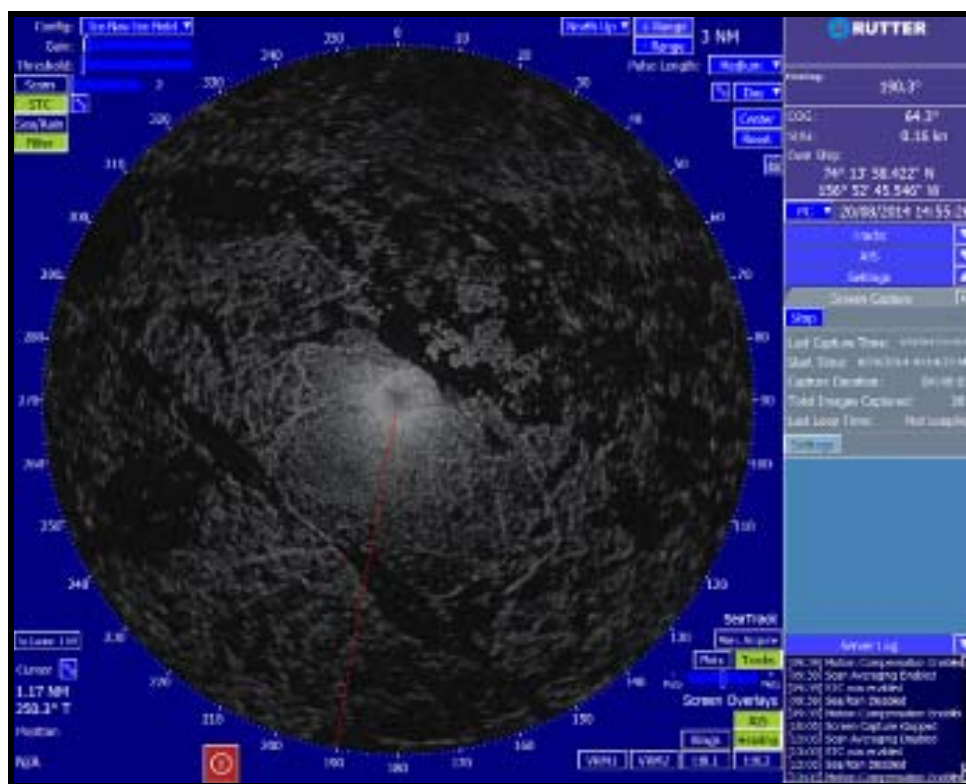
Figure 25. Ship is stuck in a large ice floe (3 nm range scale).

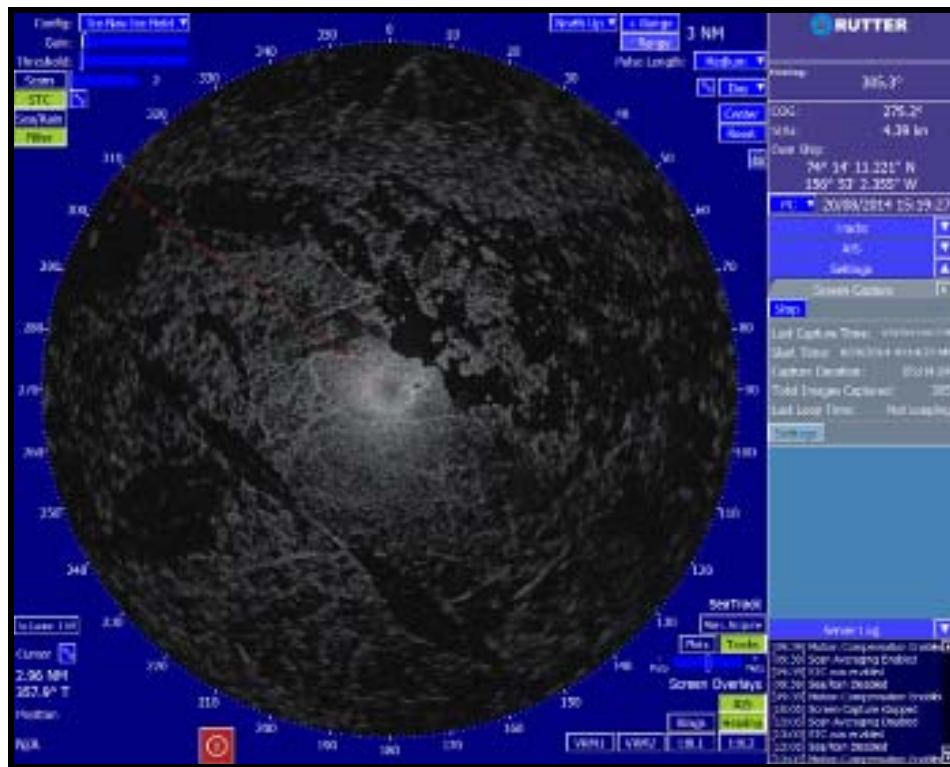
Figure 26. Ship attempting to extricate itself from the ice floe (3 nm range scale).

The crew attempted to remove the USCGC Healy from the ice floe but again, it did not consult the Ice Navigation radar. While attempting to continue breaking through the ice floe instead of reversing course, the ship became trapped in the ice floe for the second time. Figures 26 to 28 represent an eight minute timeframe of the entire hour that the ship was unable to create a clear path for itself. Little progress was made over an hour from 3:15 PM to 4:15 PM. Figure 29 was the CG radar display that the OOD relied on during the extrication of the ship from the ice floe. From the CG radar, there was little information about the surrounding ice when compared to Figure 28 and may have led the OOD to assuming that the next attempt through the ice floe would be easier than the first. Figure 30 shows the heavy fog encountered during this incident, increasing the dependency on the radar for a more efficient navigation. However, the Ice Navigation radar was little used during this sequence of events.

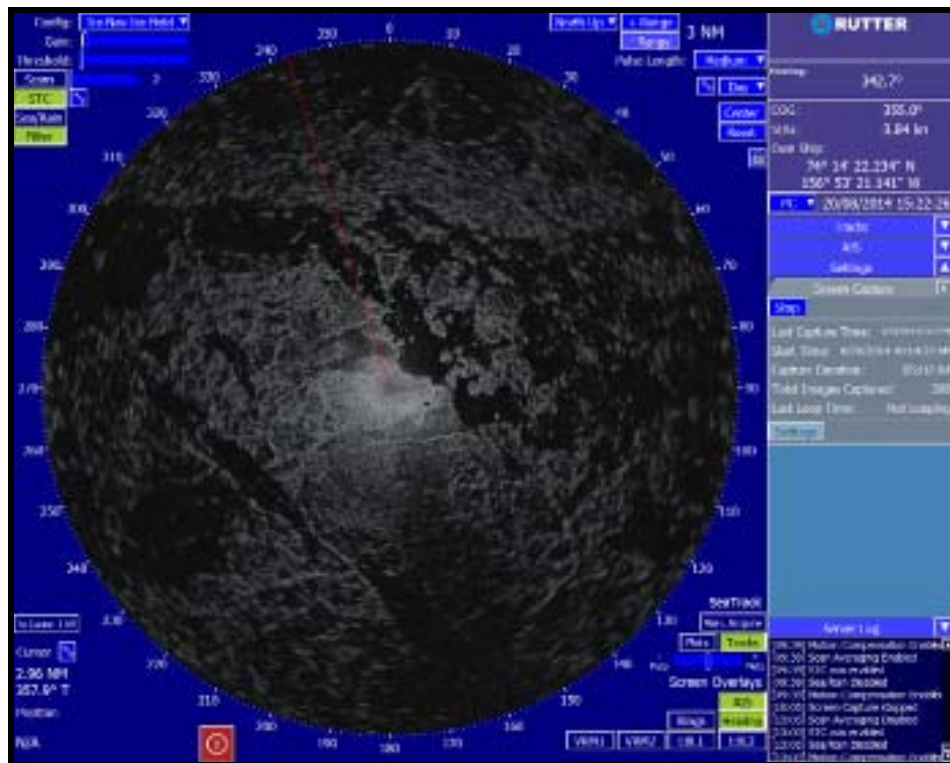
Figure 27. Ship attempting to extricate itself from the ice floe (3 nm range scale).

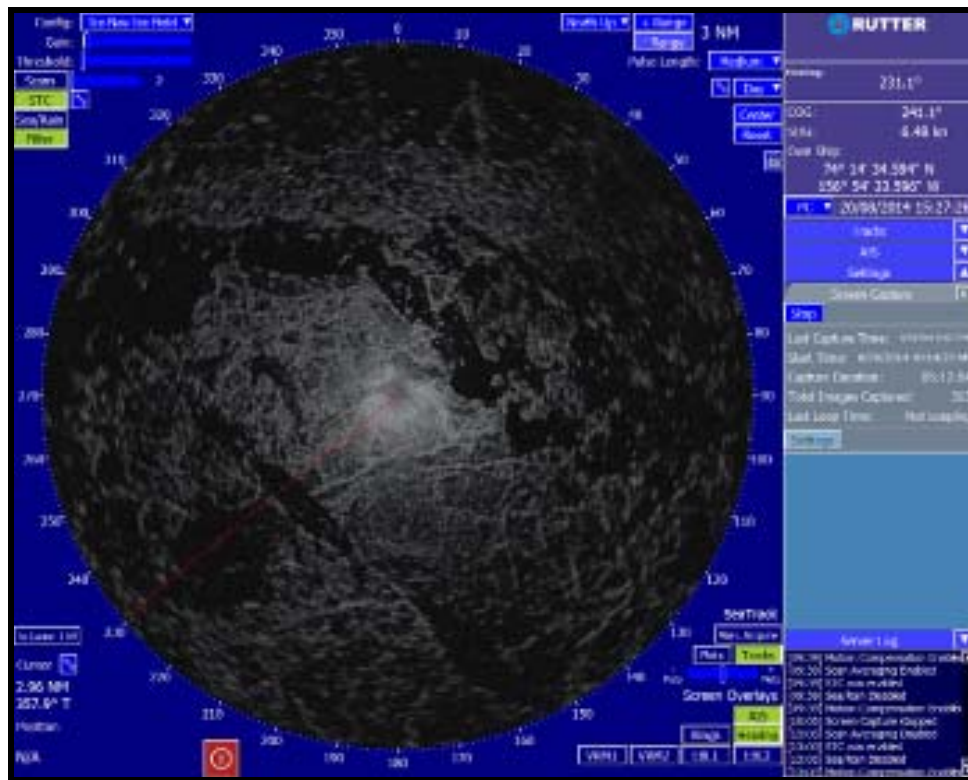
Figure 28. Ship attempting to extricate itself from the ice floe (3 nm range scale).

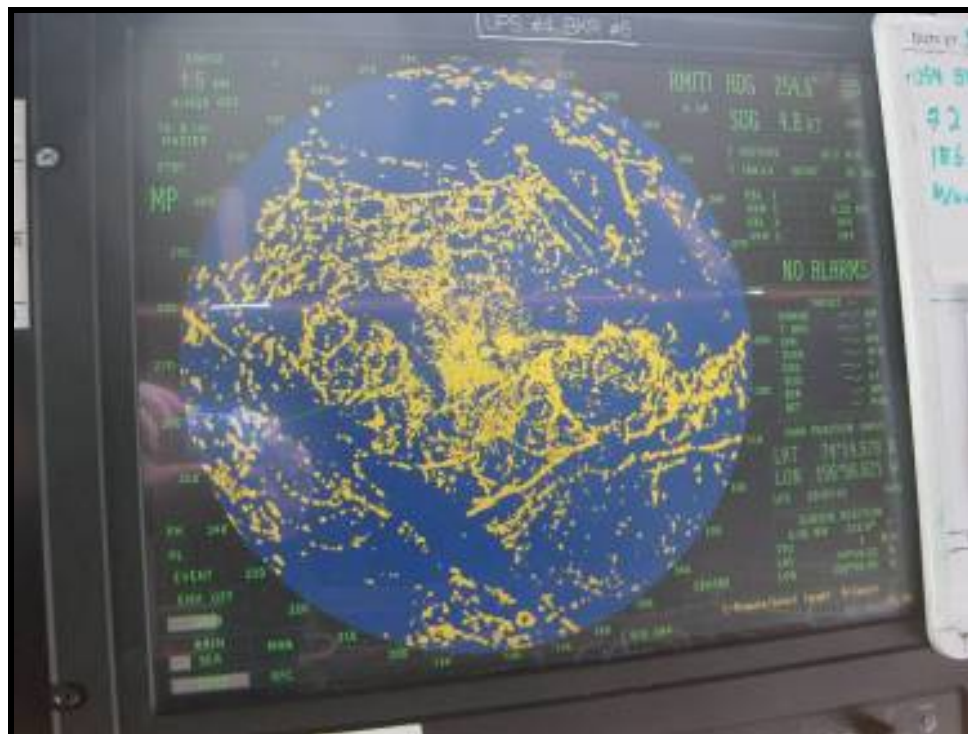
Figure 29. CG radar display while ship is stuck in an ice floe (1.5 nm range scale).

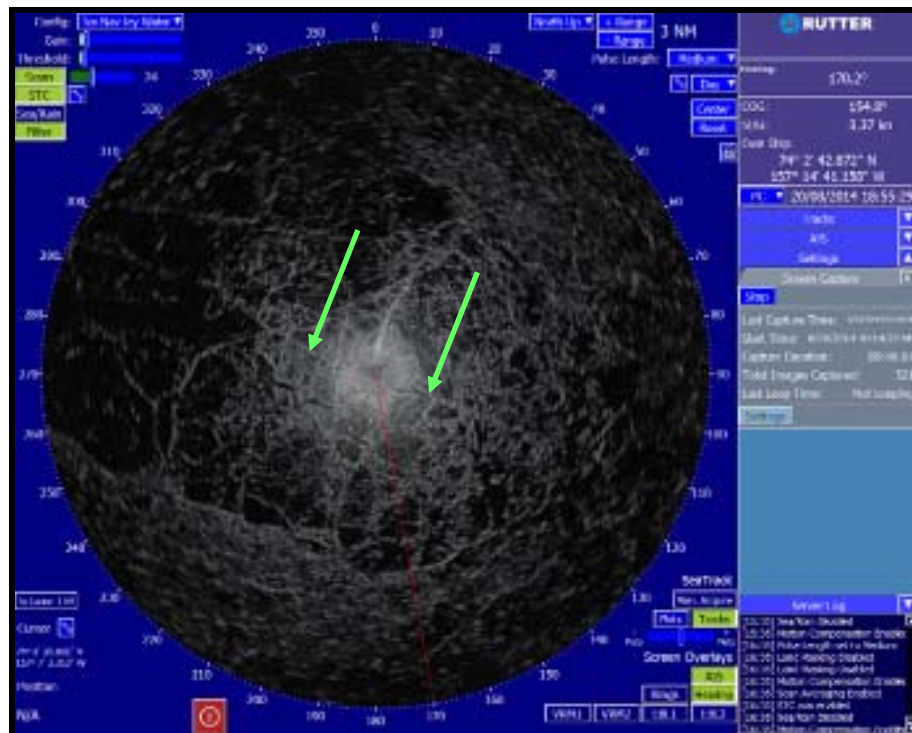
Figure 32. Ship crossing pressure ridge (3 nm range scale).
